Water Quality Management Issues in Montreal's Bouchard Creek

BREE 533: Water Quality Management - Group 9 Final Report

McGill University

28 November 2019

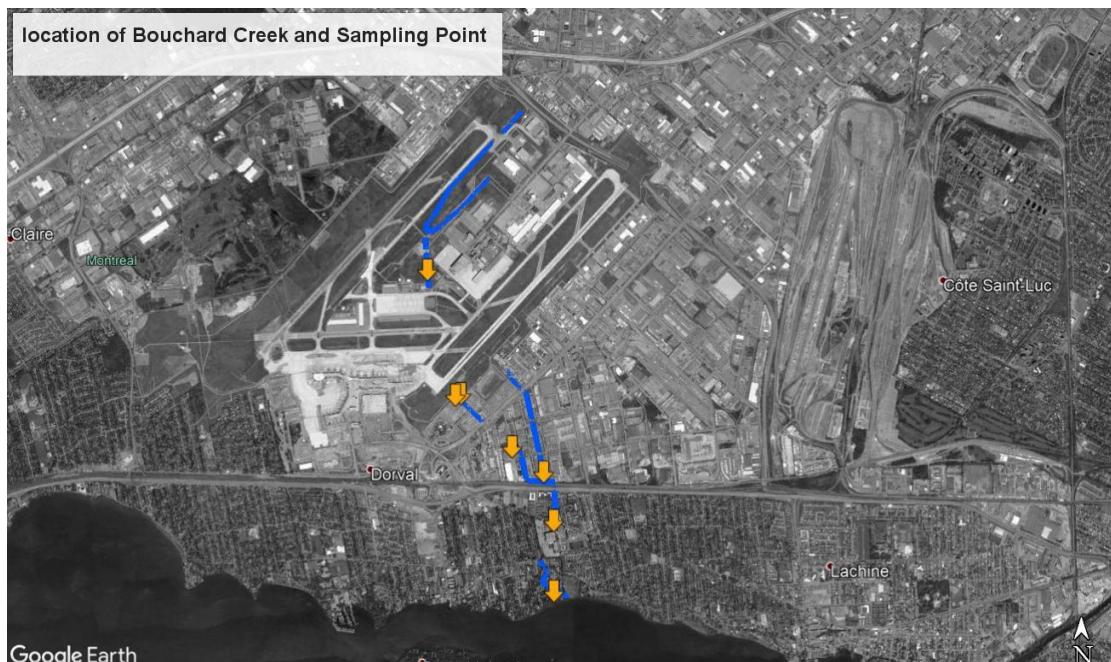
Figure 1: Route of Bouchard Creek (highlighted).

Bouchard Creek, located primarily in the city of Dorval on the island of Montreal, runs north-south for approximately 2.8 km from its beginnings on the property of Montréal-Pierre Elliott Trudeau International Airport to Lac Saint-Louis (See figure 1). On its route, it passes through industrial zones in Dorval, under Autoroute 20, and then through mixed commercial and residential areas. For much of its length, the creek has been covered by buildings and parking lots or diverted to the city sewer system. However, the sections of the creek south of Autoroute 20 remain at least partially open and show high potential for water quality and habitat improvement.

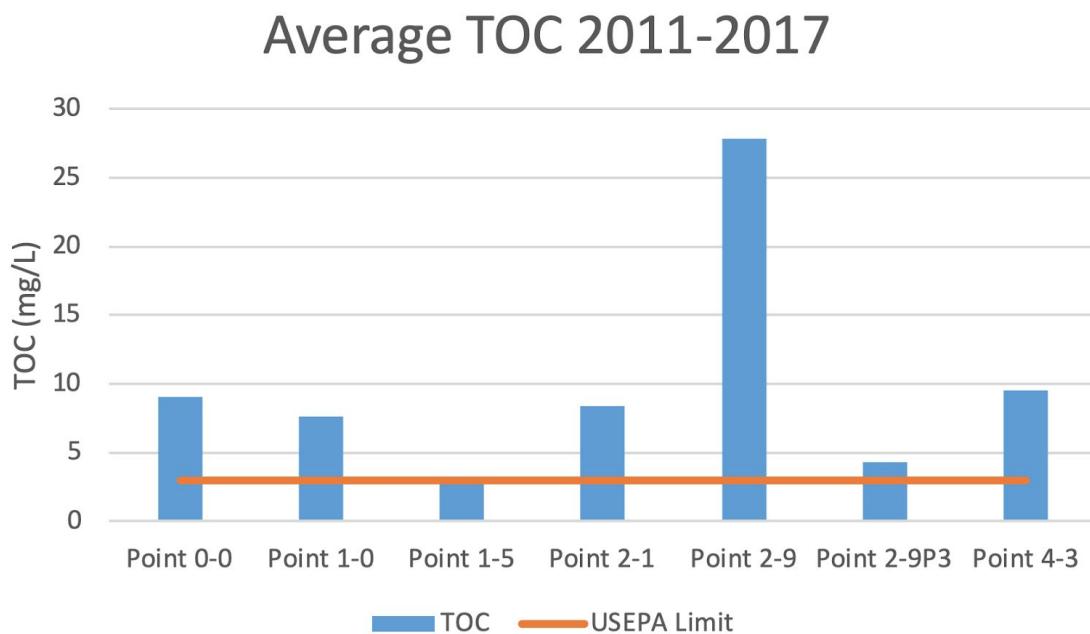
Figures 6 shows TOC in exceedance of standards based on CCME guidelines at all test points. Note the dramatically higher TOC load in station 2-9, located near the airport. We hypothesize that this is related to aircraft de-icing operations that utilize ethylene glycol and other organic compounds, which subsequently drain to Bouchard Creek near this point. Further analysis is required to evaluate this possibility.

Figure 6: Average Observed Total Organic Carbon

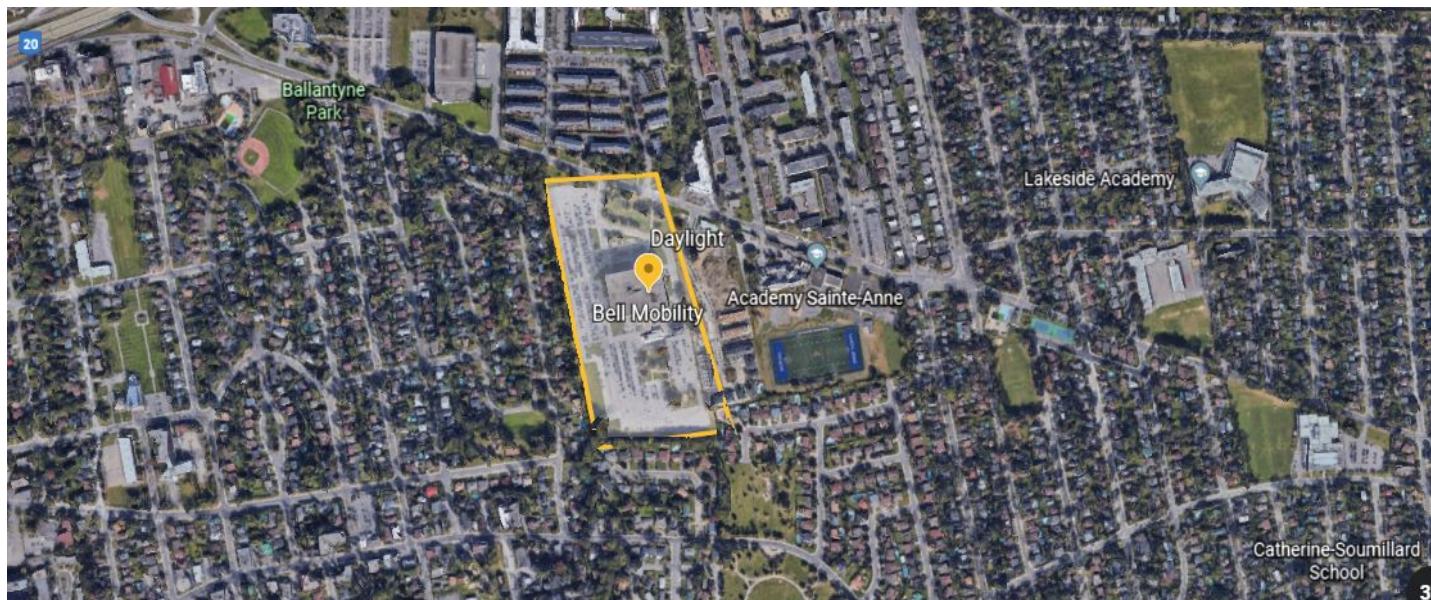
One particularly long stretch of Bouchard Creek that has been diverted underground and that could be the focus of a daylighting project is underneath the property of a Bell

Canada call center in Dorval (See figure 16), which is currently surrounded by a large parking lot. The construction of a multi-level parking garage with a smaller area or elimination of some parking spots could create the space necessary for the restoration of Bouchard Creek in this area and could serve as a model for similar stream restoration projects, in addition to generating positive publicity for the landowner and increasing abutting property values.

Figure 8: Possible site to establish a daylighting structure

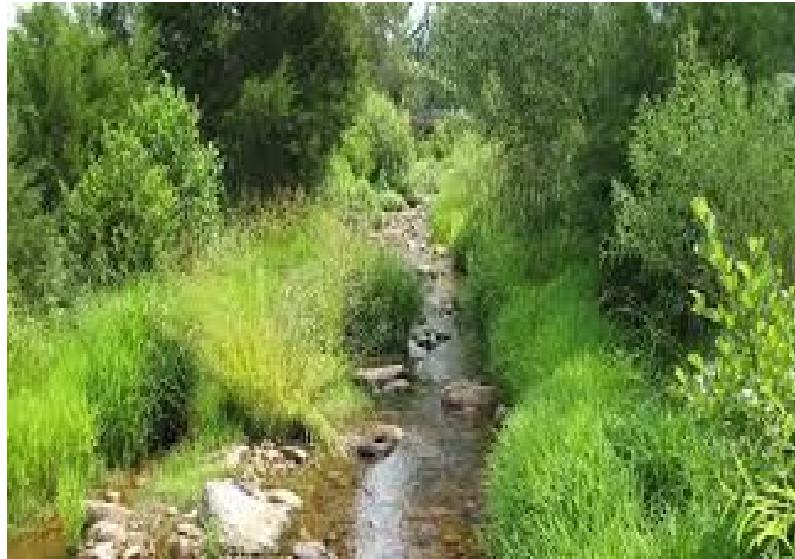
Figure 10: Example of vegetation buffer (<https://thejamesriver.org/>)
